Manhole Inspection Summary

Manhole # S29GG_001MH

Insp Date: **1/4/07 10:30 AM**

Location Address: **243 LAFAYETTE AVE**

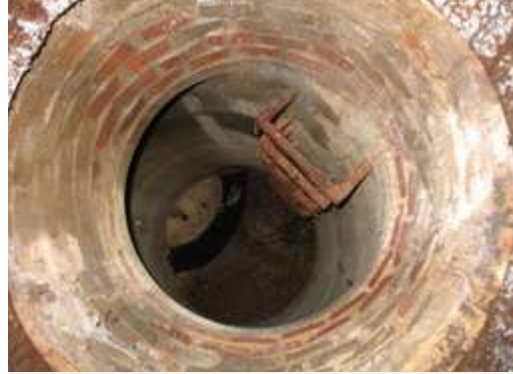
Top View

Adjustment deterioration and infiltration. Corbel and Barrel infiltration. Evidence of surcharge - Bench debris.

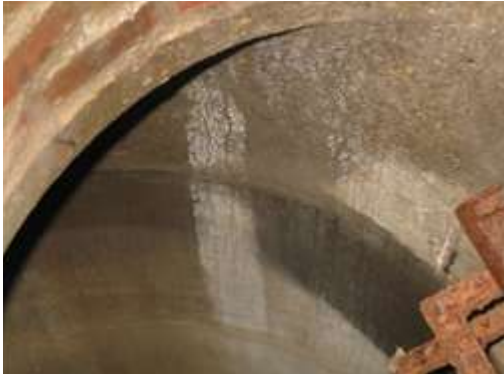
Defect

Barrel infiltration.

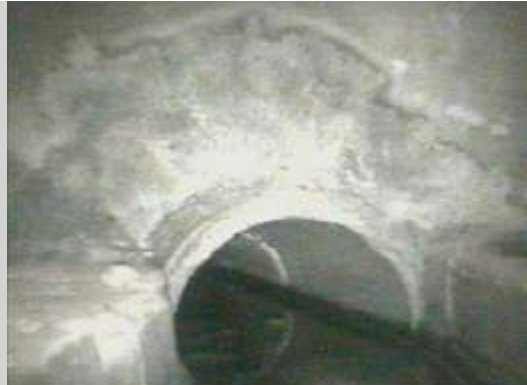
8 in. Circular Gravity Sewer Pipe Out @ 12 O'Clock

Infiltration: **Evidence** Pipe Seal Cond: **Unknown**

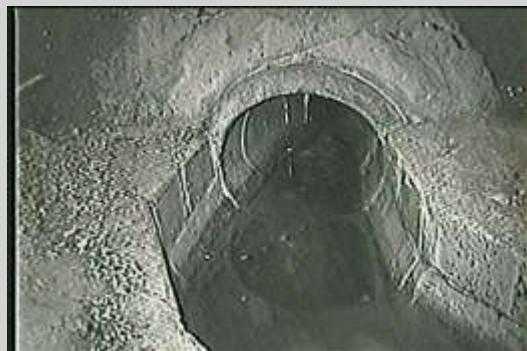
8 in. Circular Gravity Sewer Pipe In @ 9 O'Clock

Infiltration: **Evidence** Pipe Seal Cond: **Unknown**
